# Environmental Management Program Performance Assessment Report

19 October 2020

Tendele Coal Mining (PTY) Ltd

GCS Project Number: 20-0635

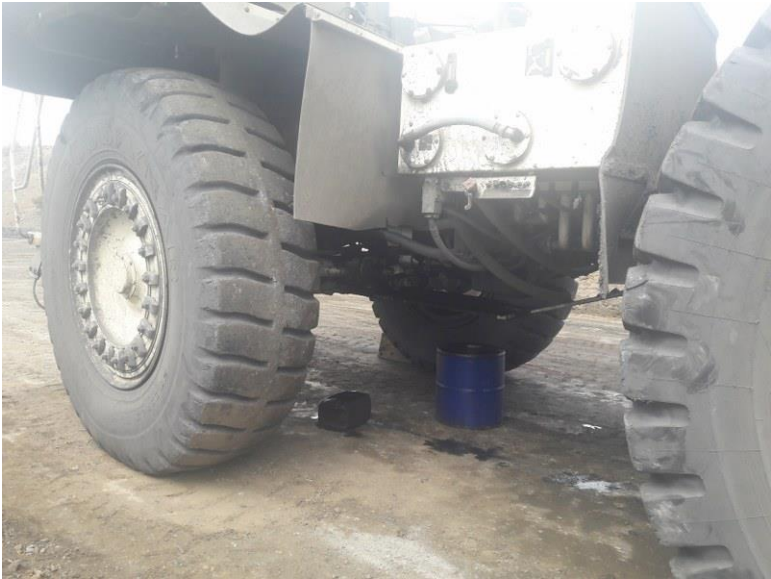
| Figure 6-7 Incorrect size of drip tray used, resulting in oil spills while servicing machinery in Hard Park Area 1 (Negative observation). | Figure 6-8 Incorrect disposal of hazardous waste in hard park, Area 1. | Figure 6-9 Oil drums standing outside store on bare soil at hard park, Area 1 (Negative observation). |

| | Drip trays must be sized to allow the equipment to be placed inside it, must be cleaned regularly, and must not be allowed to overflow. If the item is too large to fit within the tray, the tray must placed below the item and must be sized to cover all potential leakage areas. | Incorrect sized drip trays was used for vehicle servicing in the hard park, Area 1. | No | Figure 6-7 |

| Drip trays must be sized to allow the equipment to be placed inside it, must be cleaned regularly, and must not be allowed to overflow. If the item is too large to fit within the tray, the tray must be placed below the item and must be sized to cover all potential leakage areas. | Incorrect sized drip trays were used for vehicle servicing in the hard park, Area 1. | No | Spill trays of correct size must be placed under vehicles and machinery when they are not in use. Corrective action must be taken to clean up any spills. It is recommended that a register of all spills are kept and incidents are recorded and followed up. Training should be provided to employees on the spill procedure. |

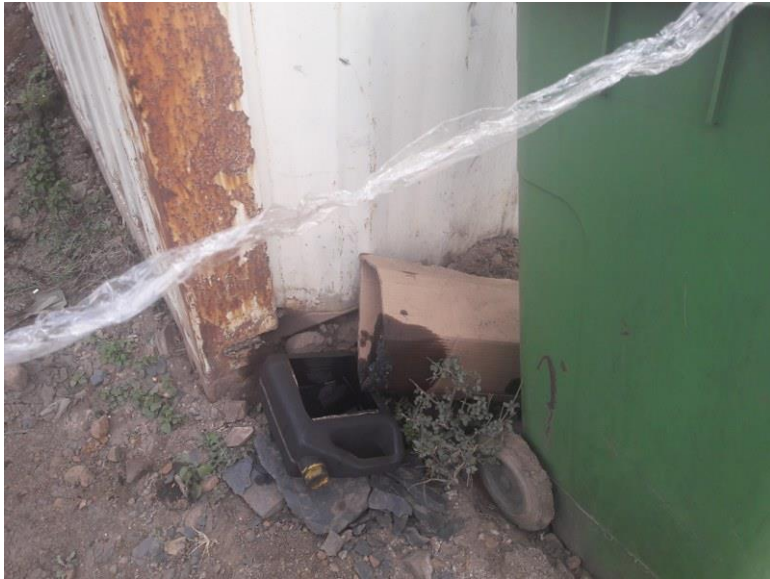
| To reduce the potential for contamination of surface water resources: Spills of Hazardous Substances | The accidental or negligent spillage of fuels or potentially hazardous substances must be cleaned up immediately using the most appropriate methodologies, equipment and materials. | Incorrect disposal of hazardous waste in hard park, Area 1. | No | Figure 6-8 |

The storing and disposal of oils and/or hydrocarbons were noted to be compliant across site except for in the hard park Area 1. It was noted in this area that oil drums were stored outside the allocated oil storage area and incorrect disposal of hazardous waste was evident.

| The accidental or negligent spillage of fuels or potentially hazardous substances must be cleaned up immediately using the most appropriate methodologies, equipment and materials. | Incorrect disposal of hazardous waste in hard park, Area 1. | No | Hazardous waste should be disposed of correctly to prevent any spills. Corrective action must be taken when spills occur. It is recommended that a register of all spills are kept and incidents are recorded and followed up. Training should be provided to employees on the spill procedure. |

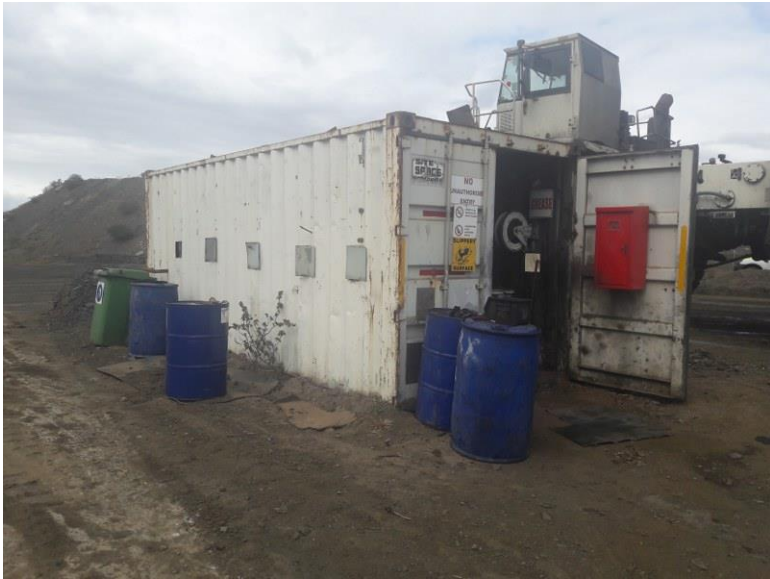
| | Chemicals must be stored in an area with an impermeable base (e.g. concrete or plastic lining). | Oil drums observed standing outside bunded storage area with no drip trays underneath in hardpark of Area 1. | No | Figure 6-9 |

| Required Action | 2020 Audit Result | Compliance | Corrective Action |
|---|---|---|---|
| Chemicals must be stored in an area with an impermeable base (e.g. concrete or plastic lining). | Oil drums observed standing outside bunded storage area with no drip trays underneath in hardpark of Area1. | No | All chemicals must be stored within bunded storage areas with an impermeable surface. |

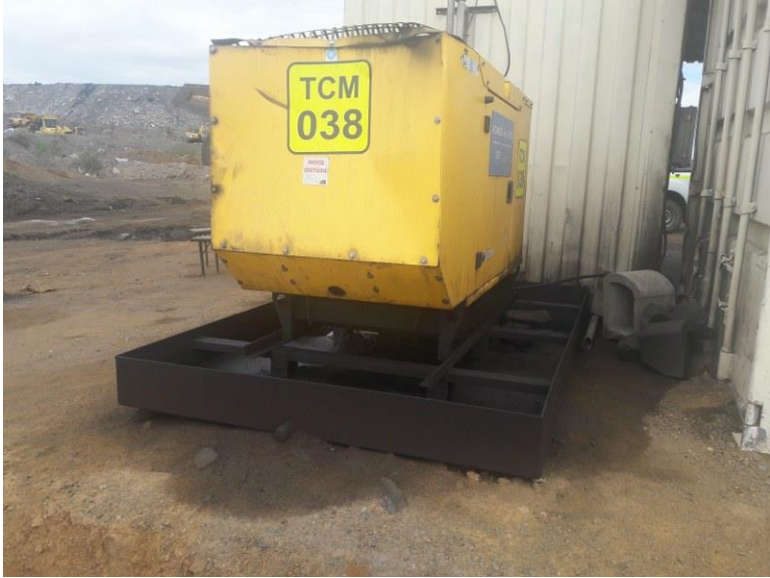
| Figure 6-10 Soil erosion evident at waste rock dump, Area 1 (Negative observation). | Figure 6-11 Erosion visible on the north western side of the discard dump. (Negative observation). | Figure 6-12 Diesel spill observed at the generator located in Hard Park Area 8 (Negative observation). |

| | Any generators used on site are to be underlain by an impermeable surface (e.g. concrete bund) or placed within a drip tray to intercept leaks. | Generator in hardpark Area 8 was not underlain by an impermeable surface and a diesel spill observed at this generator. | No | Figure 6-12 |

| Required Action | 2020 Audit Result | Compliance | Corrective Action |
|---|---|---|---|
| Any generators used on site are to be underlain by an impermeable surface (e.g. concrete bund) or placed within a drip tray to intercept leaks. | Generator in Hardpark Area 8 was not underlain by an impermeable surface and a diesel spill was observed at this generator. | No | Generator must be underlain by an impermeable surface (e.g. concrete bund) or placed within a correctly sized drip tray to intercept leaks. Corrective action must be taken to clean up existing spill. It is recommended that a register of all spills are kept and incidents are recorded and followed up. Training should be provided to employees on the spill procedure. |

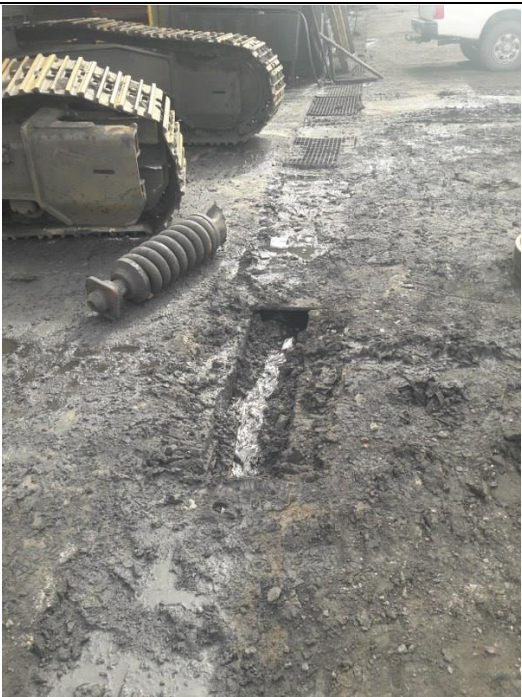
| Figure 6-13 Drains were not maintained resulting in dirty run off from workshop on to bare soil (Negative observation). | Figure 6-14 Oil spill kits were available in workshop areas (Positive observation). | Figure 6-15 Oil and chemical stores locked in the general workshops (Positive observation). |

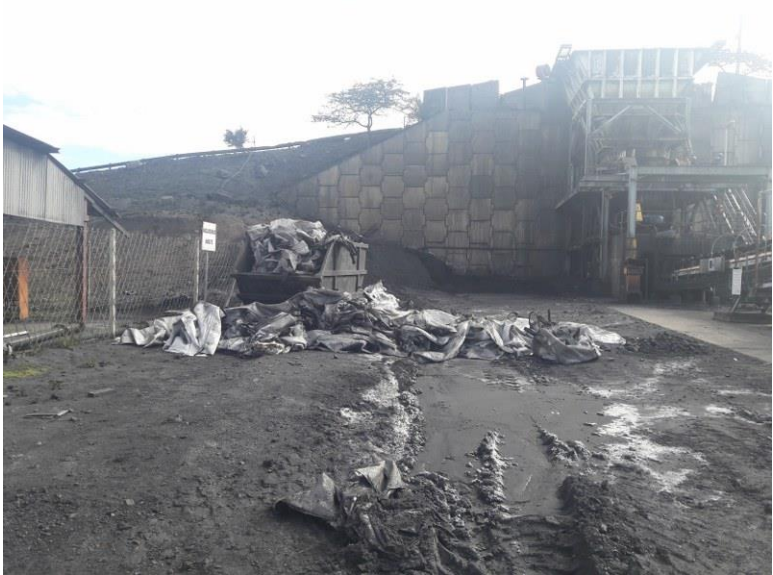
| Figure 6-16 Waste separated, and skips covered (Positive observation). | Figure 6-17 Material Safety Data Sheets (MSDS) available (Positive observation). | Figure 6-18 Waste skip overflowing and waste lying next to it (Negative observation). |

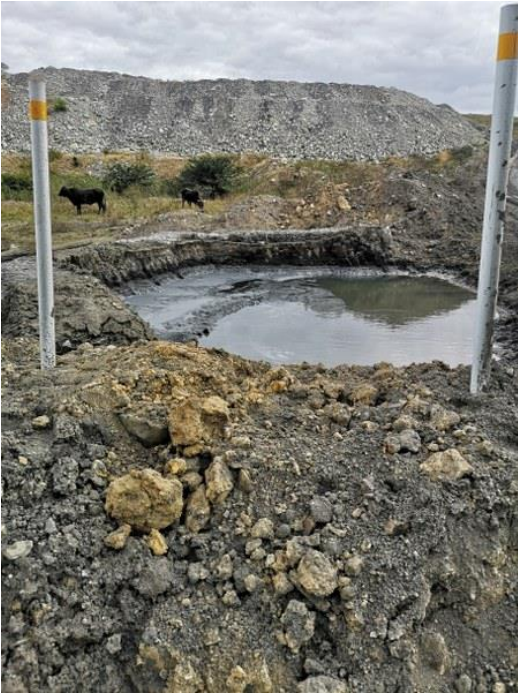
| Figure 6-22 Ponding of water next at the Luhlanga Road crossing (Negative Observation). | Figure 6-23 Continual flow of water with ponding next to the road downstream from North Pit RWD (Negative observation). | Figure 6-24 Culvert silted up at stream crossing at Luhlanga impeding water flow (Negative observation). |

| 2020 EMP Somkhele | | | | |
|---|---|---|---|---|
| Free flow of surface water to prevent ponding | The levels will be surveyed and checked upon rehabilitation | Ponding of water was observed at two areas on site. | No | Figure 6-22 and Figure 6-23 |

| Required Action | 2020 Audit Result | Compliance | Corrective Action |
|---|---|---|---|
| Free flow of surface water to prevent ponding | Ponding of water was observed at two areas on site. | No | Water leaks should be investigated and repaired as well as the maintenance of stormwater channels should be done to ensure free flow of water. |

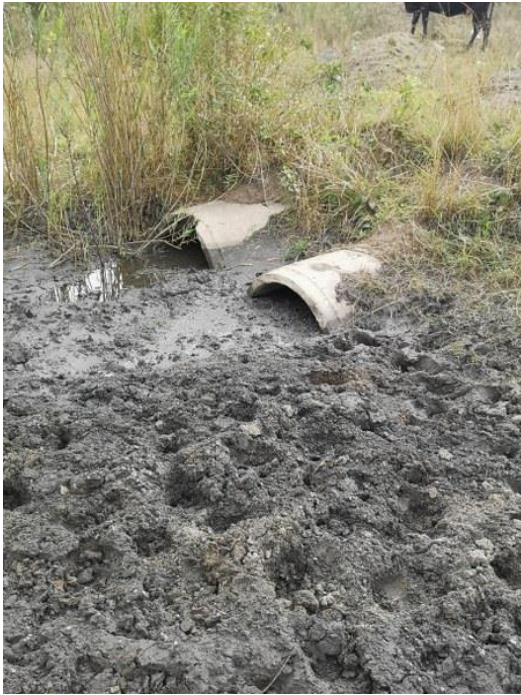
| Limit the impact on ecological sensitive watercourses | Where haul roads need to cross watercourses ecologically sensitive water resources (medium-high EIS rating), these should ideally be located at existing crossings. If this is not feasible, the crossings should be located in degraded areas of riverine habitat to limit potential impacts. | Stream crossing at Luhlanga has interrupted the river continuum and water flow and requires to be rehabilitated. | No | Figure 6-24 |

A major area of concern noted year upon year, including this year's EMP assessment, is the river crossing at Luhlanga. Pipe culverts were installed to assist with water flow at the crossing however due to poor maintenance, the pipes have silted up resulting in an impediment of water flow and obstruction of aquatic fauna movement at the crossing.

| Required Action | 2020 Audit Result | Compliance | Corrective Action |
|---|---|---|---|
| Where haul roads need to cross watercourses ecologically sensitive water resources (medium-high EIS rating), these should ideally be located at existing crossings. If this is not feasible, the crossings should be located in degraded areas of riverine habitat to limit potential impacts. | The culverts at the KwaLuhlanga River crossing is silted up and impediment of aquatic fauna and stream flow will take place. | No | The culverts installed required to be cleaned from silt build up to ensure that water flow is not impeded. |
