# Environmental Management Program Performance Assessment Report

19 October 2020

Tendele Coal Mining (PTY) Ltd

GCS Project Number: 20-0635

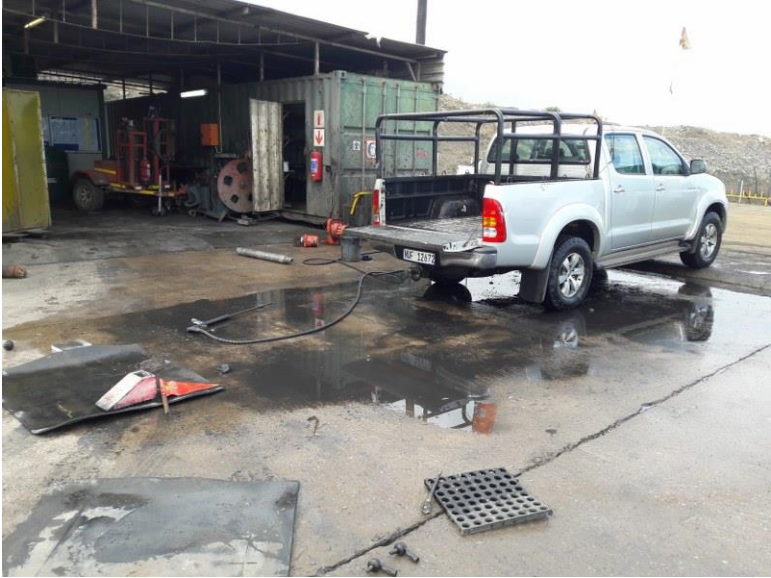
| Figure 6-1 Wash and workshop area underlain with concrete at Duma Manje Workshop with oil trap installed (Positive observation). | Figure 6-2 Oil spill kit was available in oil storage area at Duma Manje Workshop (Positive observation). | Figure 6-3 Staff notice board with copies of latest toolbox talk (Positive observation). |

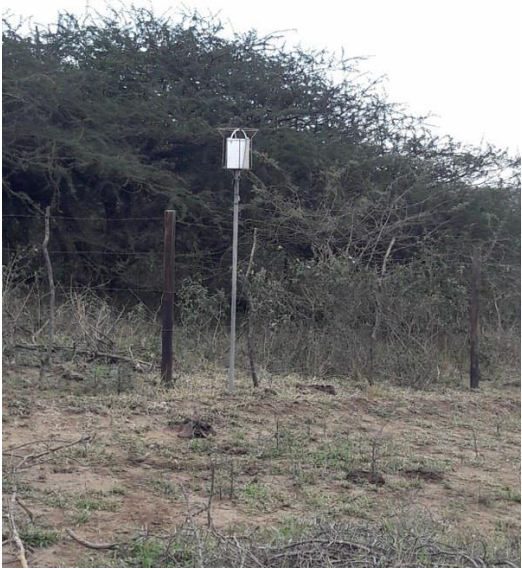
| Figure 6-4 Dust monitoring taking place on mine site (Neutral observation). | Figure 6-5 Rehabilitation at North Pit 1. Placement of topsoil (in yellow circle) (Positive observation). | Figure 6-6 Hydroseeding of rehabilitated areas in Area 1 (Positive observation). |

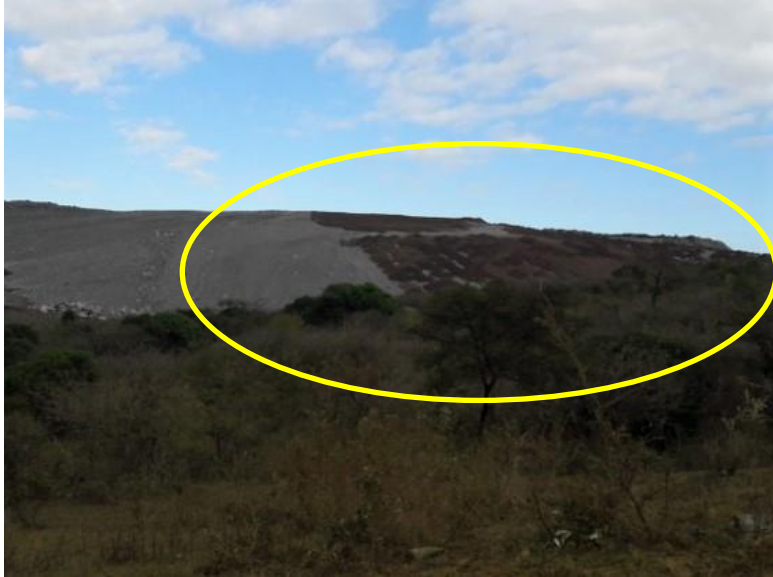
| 2020 EMP Somkhele | | | | |
|---|---|---|---|---|
| | Soils will not be placed on slopes with a gradient greater than 6%. | No rehabilitated areas currently exceed 6%. | Yes | Figure 6-5 |

| | Monitor rehabilitation in the long-term to ensure that the desired habitat is created for the re-colonisation of fauna. | Rehabilitation of pits ongoing. The backfilling of North Pit has commenced. | Yes | Figure 6-5 |

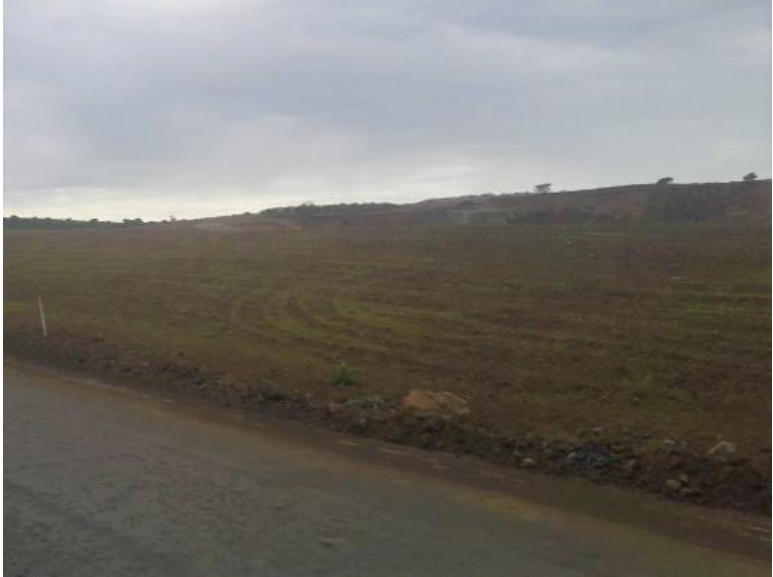
| 2020 EMP Somkhele | | | | |
|---|---|---|---|---|
| | Limiting the access of vehicles onto the rehabilitated land. | Areas being rehabilitated were not accessed by vehicles. | Yes | Figure 6-6 |

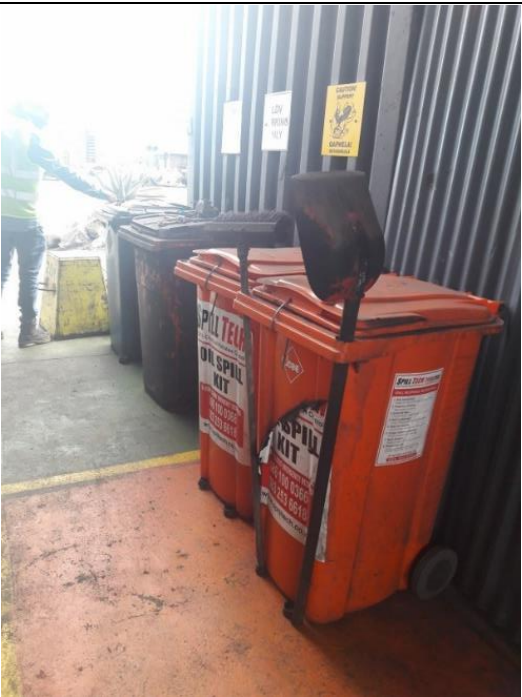
| Figure 6-13 Drains were not maintained resulting in dirty run off from workshop on to bare soil (Negative observation). | Figure 6-14 Oil spill kits were available in workshop areas (Positive observation). | Figure 6-15 Oil and chemical stores locked in the general workshops (Positive observation). |

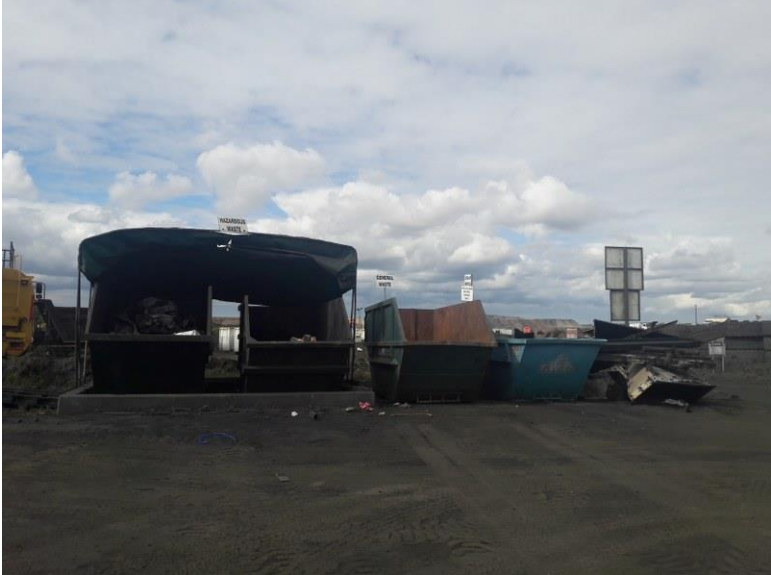
| Figure 6-16 Waste separated, and skips covered (Positive observation). | Figure 6-17 Material Safety Data Sheets (MSDS) available (Positive observation). | Figure 6-18 Waste skip overflowing and waste lying next to it (Negative observation). |

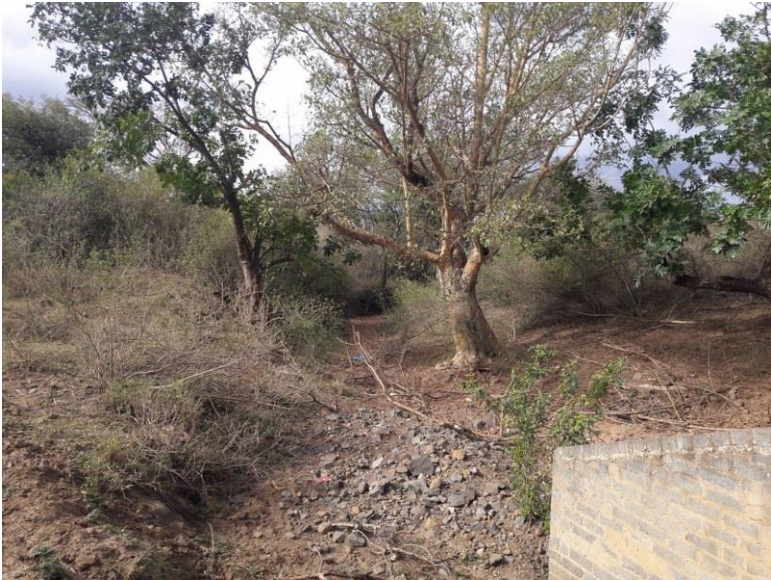
| Figure 6-19 Biannual SASS5 Monitoring site (Positive observation). | Figure 6-20 Flammable chemicals stored separately (Positive Observation). | Figure 6-21 Portable toilets utilised on site (Neutral observation). |
